DRAIN SOLUTIONS

STAMFORD WASTE
TREATMENT WORKS

INITIAL INVESTIGATION WORKS

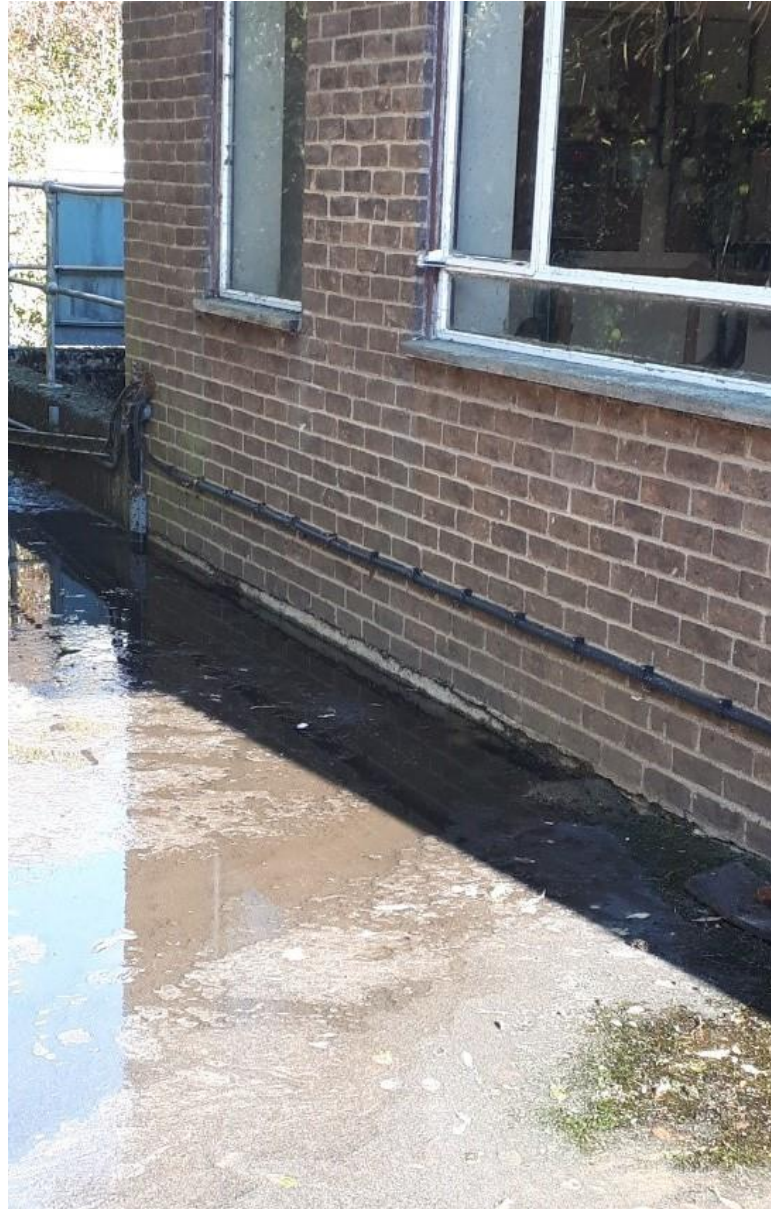
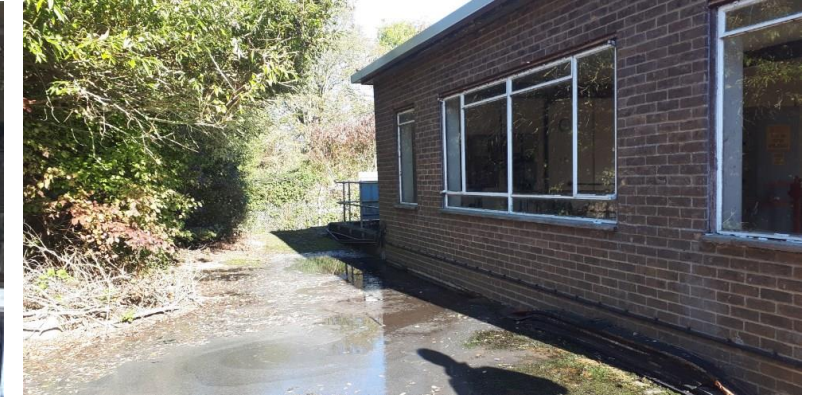
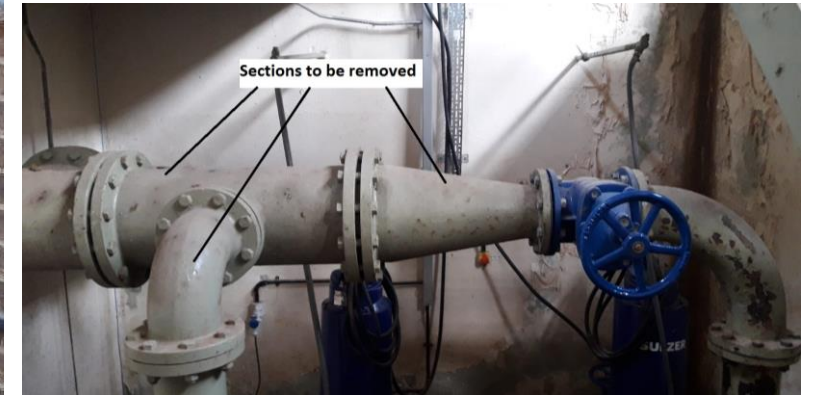
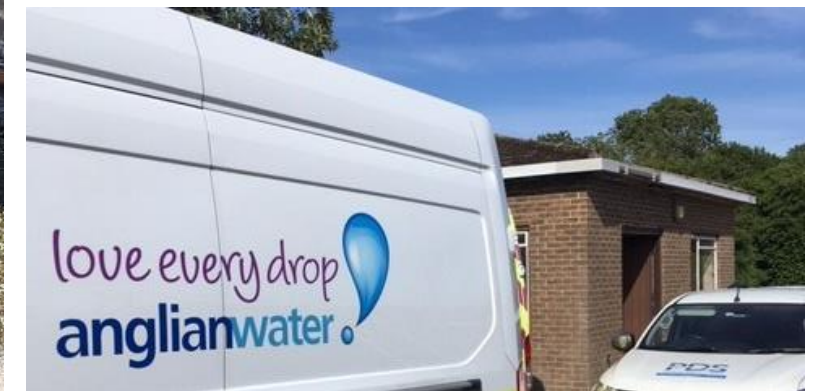
FOLLOWING THE INVESTIGATION IT WAS APPARENT THAT THE RISING MAIN FROM THE PUMP HOUSE HAD STRUCTURAL DAMAGE SITUATED 3M DEEP DIRECTLY UNDER WHERE THE POOL OF FOUL WATER HAD FORMED.

THE COSTS TO DIG WERE TOO EXPENSIVE AND DUE TO THE MAIN BEING PRESSURISED A NORMAL RESIN PATCH REPAIR WOULD NOT SUFFICE GIVEN THE PRESSURES OPERATING IN THE MAIN AND THE RISK OF A RESIN PATCH PEELING OFF AND CAUSING AN OBSTRUCTION.

WE DECIDED TO USE THE QUICK-LOCK REPAIR SYSTEM WHICH IS DESIGNED TO RESIST UP TO 10 BAR INTERNAL PRESSURE WHEN INSTALLED AND HAS A 50-YEAR SERVICE LIFE.

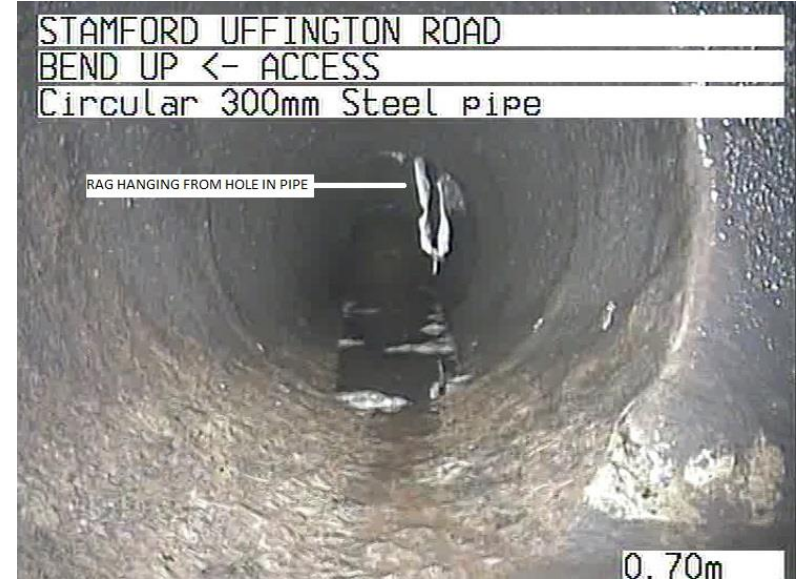
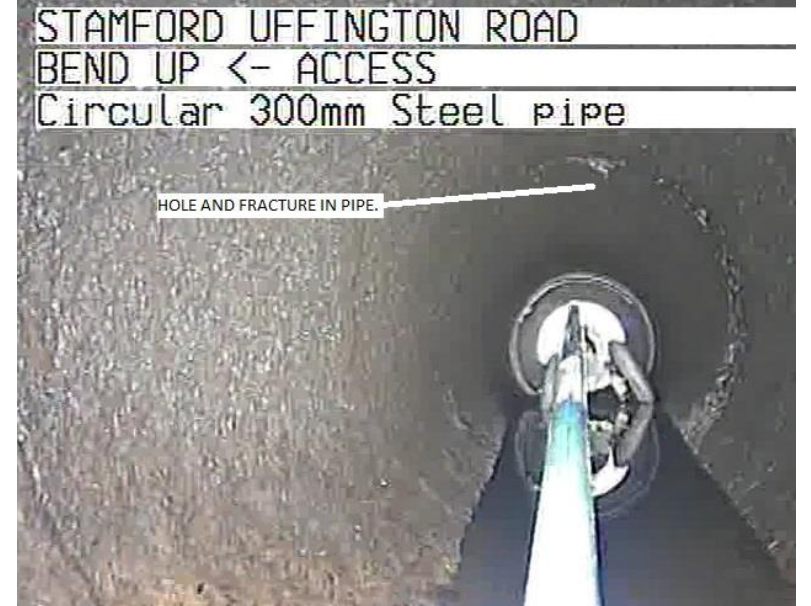
THE CCTV HIGHLIGHTED AN ISSUE WITH THE CAST IRON PIPE, THIS BEING A HOLE AND FRACTURE APPROX 2-3M INTO THE PIPE. DURING THE SURVEY THE DEFECT WAS IDENTIFIED BY A RAG HANGING DOWN FROM THE TOP OF THE PIPE WITH EVIDENCE OF AN OCCASIONAL DRIP.

WHEN THE RAG WAS REMOVED THERE WAS A GUSH OF WATER AND THEN CONTINUOUS DRIPPING. THIS THEN ALLOWED US TO SEE THAT THERE WAS A FRACTURE AND HOLE SITUATED WHERE THE RAG WAS ATTACHED.

ONCE WE WERE ABLE TO FIND THE CAUSE OF THE FLOODING ISSUE WE THEN CONTINUED WITH THE SCOPE OF WORKS AND INSTALLED THE QUICK-LOCK REPAIRS IN THE EFFECTED AREA.
